South Yarra Siding Reserve

Road Safety Audit

Audit Stage: Pre-opening

DOCUMENT NUMBER: S20220428-REP-001-B-South Yarra Siding Reserve

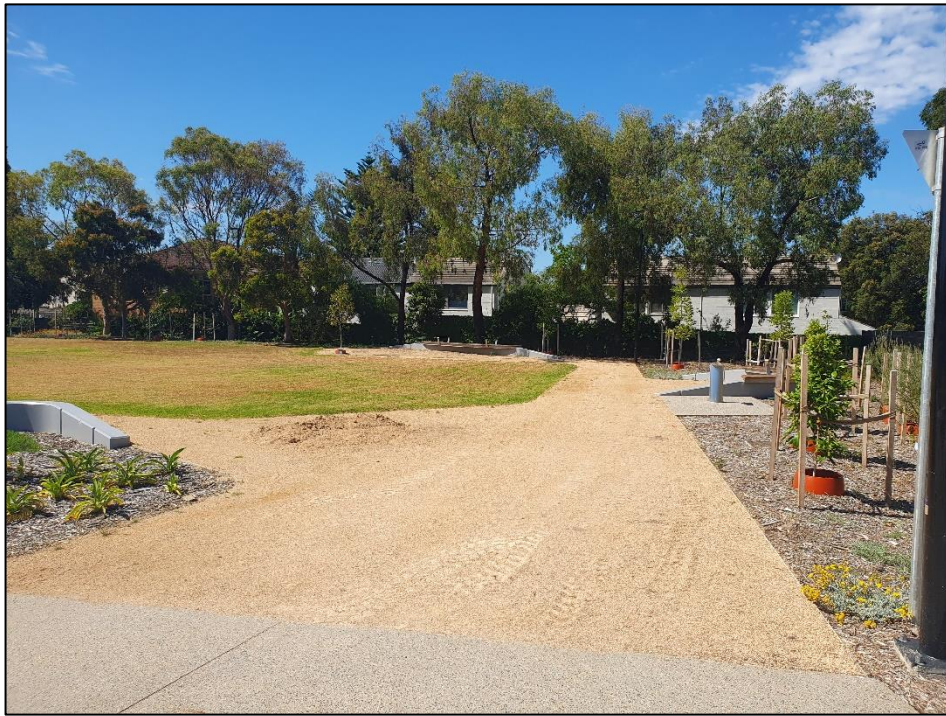
**Photo 9:** Looking towards the off-leash area access, facing south. Note unsealed entry to off-leash area.

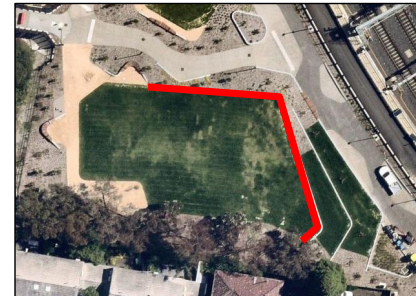
2. On the northern side of the proposed dog off-leash area there are 3 tiers, with drops of approximately 600mm (top level), 500mm (middle level) and 550mm (lower level) respectively.  Once dogs have moved off the grassed area and onto the lower levels, it may be difficult for owners to maintain eye contact with their pet. This can lead to loss of control of the dog, resulting in a collision risk between dogs and cyclists, skateboarders or scooter riders.	Unlikely	Moderate	Medium Safe System energy within tolerable levels	Consider providing a fence to restrict the movement of off-leash dogs from the designated area. As above, the fence should be installed between the north side seating area and the south east corner. (S)

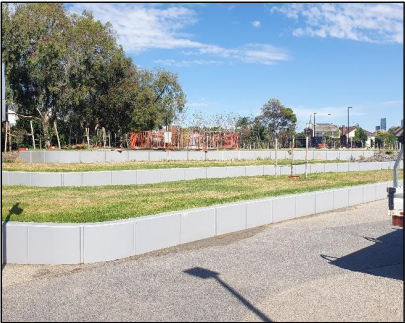
Audit Findings	Risk Assessment			Recommendations  P – Primary S – Supporting      ST – Step Towards N – Non-Safe System	Responsible Officer	
	Likelihood	Severity	Level of Risk		Accept Yes/No	Comments
<p>3. There are no steps providing formal access to these areas. These unguarded drops could be a hazard to younger children, or those with a disability.</p>

Unlikely	Minor	Low  Safe System energy within tolerable levels	<p>Consider providing a fence to restrict the movement of younger or less able children. As above, the fence should be installed between the north side seating area and the south east corner. (P)</p> <p>To note: The provision of fencing as suggested above would not have an adverse impact on universal access as wheelchair and prams can only access the site via the unsealed track on the west side, adjacent to the new rail overpass footbridge.</p>		
<p>4. Cyclists will have a downhill grade from the Osbourne St entry when heading towards William St. This increases the risk of conflict with pedestrians at the east side of the rail overpass, where pedestrians might be hidden from the cyclists view by the bridge parapets.</p>

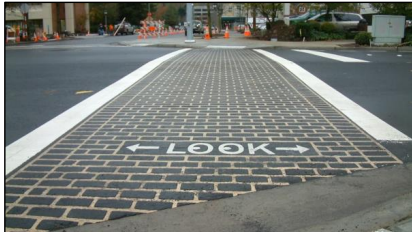
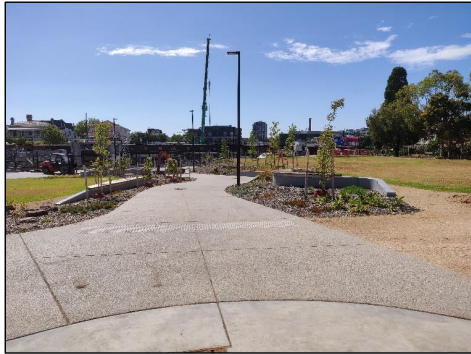
Audit Findings	Risk Assessment			Recommendations	Responsible Officer	
	Likelihood	Severity	Level of Risk		Accept Yes/No	Comments
<p>5. Cyclists heading towards William St have a sharp right turn on a downhill grade as they pass the off-leash area. This could result in loss of control crashes.</p>

Rare	Minor	Negligible Safe System energy within tolerable levels	<p>Consider installing “Slow” and/or “right hand bend ahead” pavement markings for cyclists heading east towards the right hand bend. (S)</p> <p>Consider adding lane markings (centre and edge) to help cyclists identify the line they need to take through the bend. (S)</p> <p>Consider adding “Look for cyclists” pavement for southbound pedestrians entering the SUP on the east side. (S)</p>

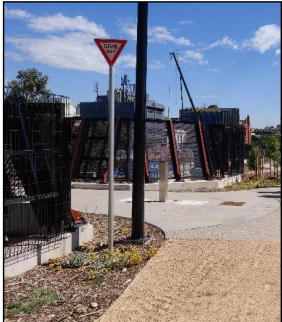
<p>6. The Give Way signage placed at the entry point to the off-leash area is very small and difficult to read. They also conflict with Road Rule 250 (2b) which gives priority to pedestrians on shared use paths.</p> <p>Regulatory signage is unlikely to be enforceable within a mixed use park.</p> <p>This could lead to conflicting user expectations and movement conflicts, resulting in collisions between pedestrian cyclists or electric scooters.</p>

Unlikely	Minor	Low Safe System energy within tolerable levels	<p>Consider removing regulatory signage and replacing with informative pavement markings as suggested in findings 2 and 3 above. (S)</p> <p>Consider installing symbolic bicycle sign with arrows on the pavement. . (S)</p>

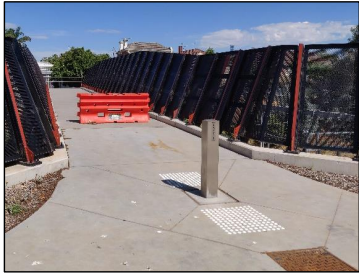
Audit Findings	Risk Assessment			Recommendations P – Primary S – Supporting ST – Step Towards N – Non-Safe System	Responsible Officer	
	Likelihood	Severity	Level of Risk		Accept Yes/No	Comments
<p>7. A steel bollard has been installed on the bridge entry point, presumably to divide bicycle flows and prevent vehicular access. These bollards can be a hazard to cyclists, particularly younger or less experienced cyclists. They can also be a hazard to pedestrians with visual impairments, which seems to have been noted by the inclusion of small areas of tactile paving either side of the bollard.</p> <p>It is also noted there is a lack of retro reflective tape installed on the bollard, although it is noted there is a light installed above this location.</p>

Unlikely	Minor	Low Safe System energy within tolerable levels	<p>Consider installing reflective tape on the bollard to increase its conspicuity at low light conditions. (S)</p> <p>Consider removing the bollard and instead use pavement arrows (together with a centre dividing line) to indicate the preferred direction of flow. (S)</p>

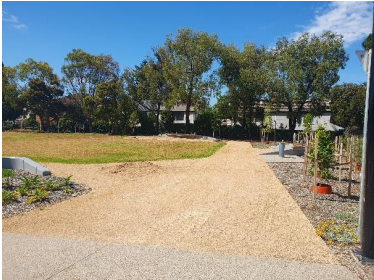
<p>8. All paths in the park are concrete, except the area that provides access to the off-leash area which is unsealed. This could limit access for the less able bodied in poor weather conditions, particularly wheelchair users, and therefore adversely impacts on universal access.</p>

N/A	N/A	To Note	<p>Consider sealing a short section of the unsealed area, to ensure the off-leash area can be accessed by all users in all weather conditions.</p>

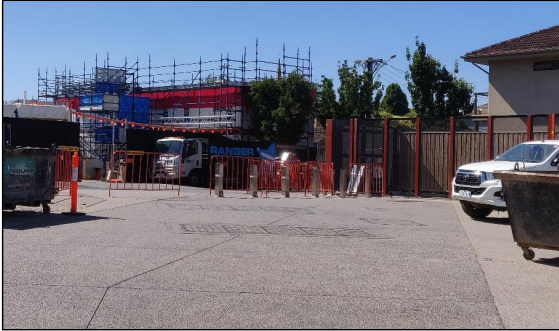
Audit Findings	Risk Assessment			Recommendations  P – Primary S – Supporting      ST – Step Towards N – Non-Safe System	Responsible Officer	
	Likelihood	Severity	Level of Risk		Accept Yes/No	Comments
<p>9. Steel bollards have been installed at the William Street entrance to the park – they do not appear to have any retroreflective tape installed and there are no lights installed at this location, increasing the potential for cyclists to collide with them at low light conditions.</p>

Unlikely	Minor	Low  Safe System energy within tolerable levels	Consider installing reflective tape on the bollards to increase its conspicuity at low light conditions. (S)		
<p>10. There is a service vehicle roadway on the north side of the park around the William Street entrance to provide access to the railway – railway workers may be unaware of cyclists passing through this location, increasing the potential for a collision. Noted that this gate is to be closed off and use of this access point is expected to be minimal.</p>

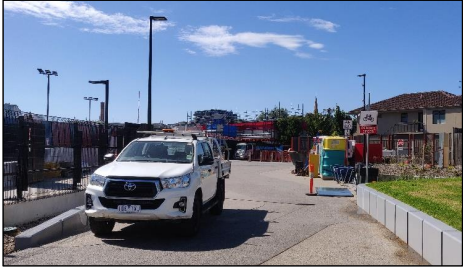
Audit Findings	Risk Assessment			Recommendations P – Primary S – Supporting ST – Step Towards N – Non-Safe System	Responsible Officer	
	Likelihood	Severity	Level of Risk		Accept Yes/No	Comments
<p>11. Signage is installed on the south side of the path for users exiting the park towards Williams Street – there is the concern that path users may not see this signage, increasing the potential for a collision.</p>

Unlikely	Minor	Low Safe System energy within tolerable levels	Consider installing additional signage on the north side of the path and supporting with pavement markings. (S)
