Heritage Citation – Individual Place

Heritage Place: Toorak Primary School No. 3016

Address: Canterbury Road, Toorak

HO Reference: HO8

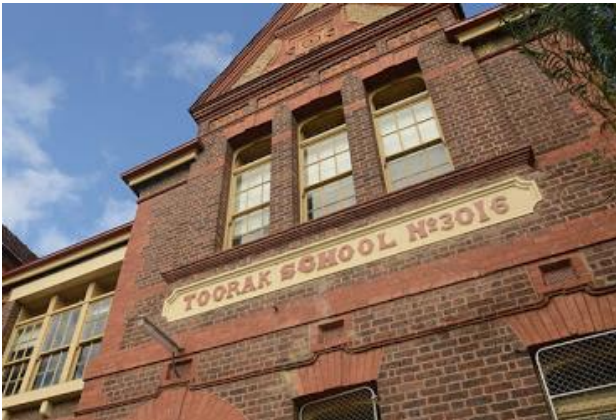
Photograph of Toorak Primary School No. 3016
(source: Toorak Primary School)

Toorak Primary School consists of a large two storey brick building and several contemporary structures located within the school grounds. The original school building consists of open face brown polychrome brick structure laid in a Flemish bond. The design of the structure is influenced by the Queen Anne Revival style. The front façade facing Canterbury Road features a stuccoed name and date plaque with expressed lettering painted red, reading 'ERECTED A.D. 1890' and 'TOORAK SCHOOL NO.3016'. The building has a robust and well anchored built form with an asymmetrical pitched and open gable roof laid in random brown and red terracotta tile. The elevations are broken up by slightly projecting open gable bays. The polychrome brown brickwork is segmented by red brick laid string courses and imitation quoining at the corners. The roof includes five tall open face chimneys with a stuccoed corbel and chimney pots. There are a number of newer round steel chimney vents along the roof ridges.

The front facade facing Canterbury Road consists of five bays that are presented asymmetrically. The smallest bay to the left on the south side of the elevation is a single storey secondary entrance bay with a lean-to hipped roof. The main entrance is raised up three steps and has a double door with sidelights and fanlight. The door and window joinery on the structure consist of timber painted a light cream colour. The next bay features a bank of three single hung six pane sash windows and three pane fanlight with a concrete sill and lintel matching the colour of the elevation's timber elements. The ground level windows and doors are protected by galvanised chain link security screens. The upper level features a group of three centred windows. The three single hung six pane sash windows and arched fanlight are recessed on the elevation and framed by an expressed brick bay. The windows sit on a stuccoed black sill and expressed shaped open face brick skirt. The windows have a red brick flat gauged arch. The bay features a rough cast frieze under the timber fascia and gutter. The corresponding fourth bay presents a similar elevation to the second bay.

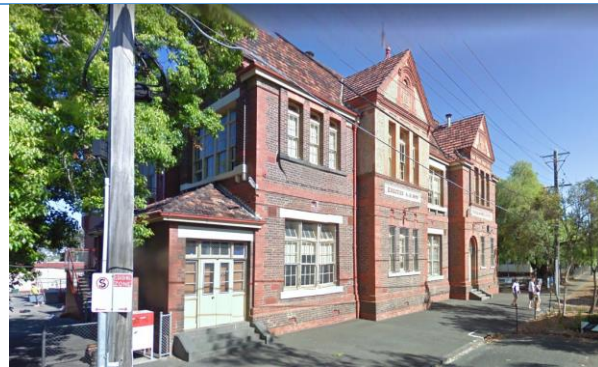
Overview of the school building (source: Google Streetview, 2009).

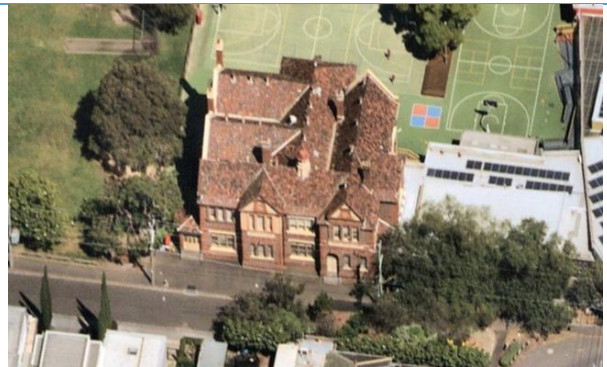
Oblique aerial view of eastern elevation (source: NearMap, 2021).

The next bay located at the centre of the east elevation is a projecting open gable bay. The ground level features a centred group of three widows in a similar style to the previous bay. However instead of a

concrete lintel, the tops of the windows are emphasised with a stylised flat gauged arch, fine string course moulding and recessed detailing in a square form all laid in a red brick. The upper level consists of the date plaque. The brick face is interrupted above the date plaque by a red shingle skirt course and the rest of the wall above is rendered in a roughcast stucco. The upper-level windows present in a similar style to the previous bay except the expressed brickwork around the windows are finished in a smooth stucco. The upper level is separated from the open gable by a well-defined shingle skirt that continues upwards to emphasise the form of the pediment. The roughcast wall of the gable features a highly detailed decorative centred red key motif with an expressed arched cap.

The last bay on the north side of the east elevation is a projecting gable bay and which houses the original main entrance to the building. The tall arched door is accessible up three steps. There are two windows with a concrete sill and detailed flat gauged arch next to the arched door. The upper level features the stucco name plate and a group of three windows. Unlike the other projecting gable bay, this bay is only stuccoed at the gable pediment level. The gable features a similar centred key motif but without the arched cap. A prominent feature on the elevation is the octagonal roof turret with a rounded roof clad metal sheeting painted red. The turret is capped with a tall flagpole.
