Heritage Citation – Individual Place

Heritage Place: Residence
Address: 23 Douglas Street, Toorak

HO Reference: HO307
Citation status: Final
Date Updated: 17 March 2022

Year of Construction: c.1890-1895

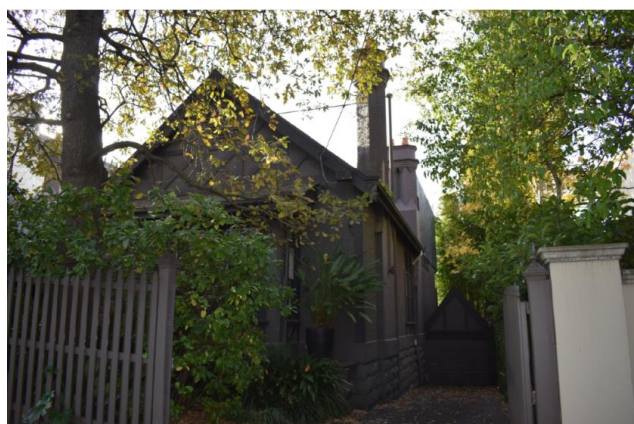
Photograph of 23 Douglas Street (source: Extent Heritage Pty Ltd, 2021).

23 Douglas Street is a double storey residence built in an Arts and Crafts style. The main structure is single storey at the front, moving to two storeys at the rear including a contemporary extension. The masonry structure is finished in a roughcast stucco. The black/grey colour of the roughcast is employed throughout the entire building and is not part of the original colour scheme. The structure employs a hipped roof with open gable projections clad in slate tiles. The front façade is almost symmetrical, with a slightly different eave treatment and fall between the two flanking open gable projections. The left gable falls lower than the right gable forming the porch awning.

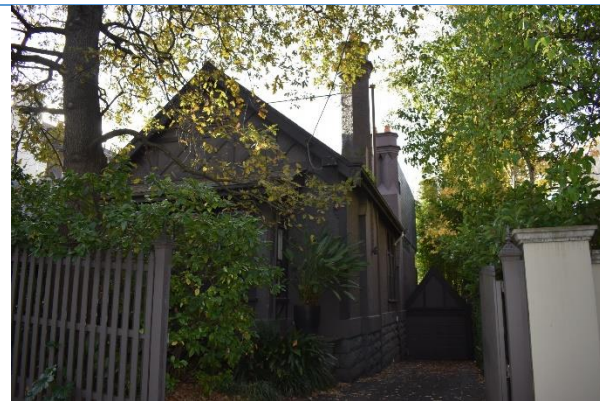
Oblique view of façade and eastern elevation (source: Extent Heritage Pty Ltd, 2021).

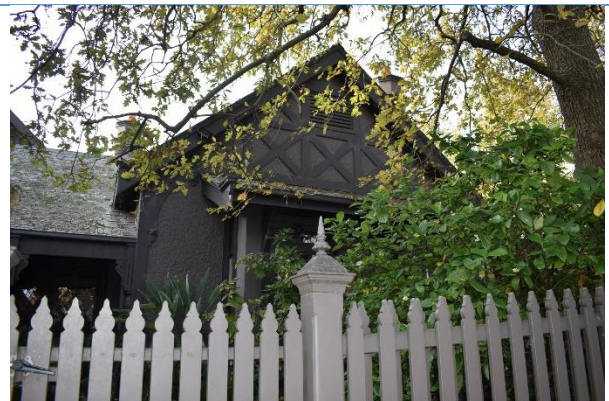
Façade details on the eastern projecting bay (source: Extent Heritage Pty Ltd, 2021).

The right gable end on the façade presents a feature bay window with a set of three windows on its front and two side windows. The windows present a same style as the left gable windows. The half timbering detail can be found under the windowsill incorporated into the sash box. The bay window is protected by a lean-to awning supported by four brackets. The half timbering battens continue above the awning incorporating the single timber louvred vent window.

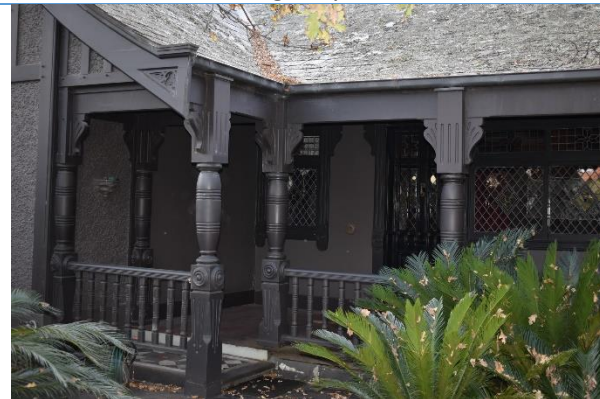
Verandah details on façade (source: Extent Heritage Pty Ltd, 2021).

The main entrance is located in between the two front gables and set under a deep porch. The porch is raised up two steps and laid with Old English tiles in a geometric pattern. The timber verandah elements are highly decorative. The turned timber posts are shaped into three distinct sections that are embellished with fluted patterns and patera motif. The porch is enclosed with a turned timber balustrade echoing similar horizontal fluting. The posts are capped with a heavy-set entablature with curved bracket-like valances. The windows along the porch wall are highly detailed diamond pattern fine leaded glass with stained glass flower motifs. The windows in the porch and along the exterior façades are set within highly detailed carved sash boxes that emulate the forms of the turned porch posts.

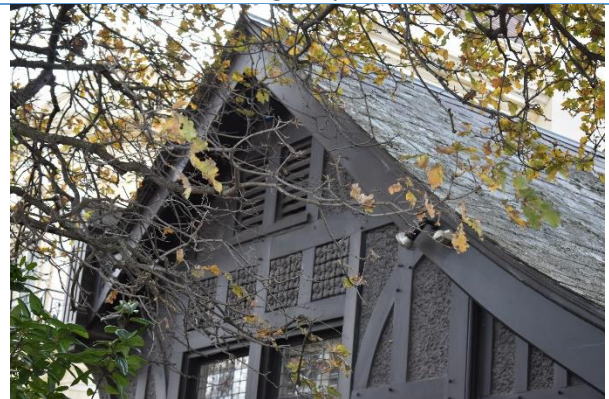
Façade details on the western projecting bay (source: Extent Heritage Pty Ltd, 2021).

The left gable end on the façade forms the porch awning with a decorated carved bargeboard at the porch end. The gable is detailed with black half-timber brackets forming the sash box of the paired

windows. The windows are a timber single hung sash window with leadlight and stained glass top light with an eight point star motif. The sash boxes extend upwards forming four equally space centred square sections each embellishes with nine cast rosette mouldings painted black. The half timbering ends under the double timber louvred vent window at the apex of the gable.

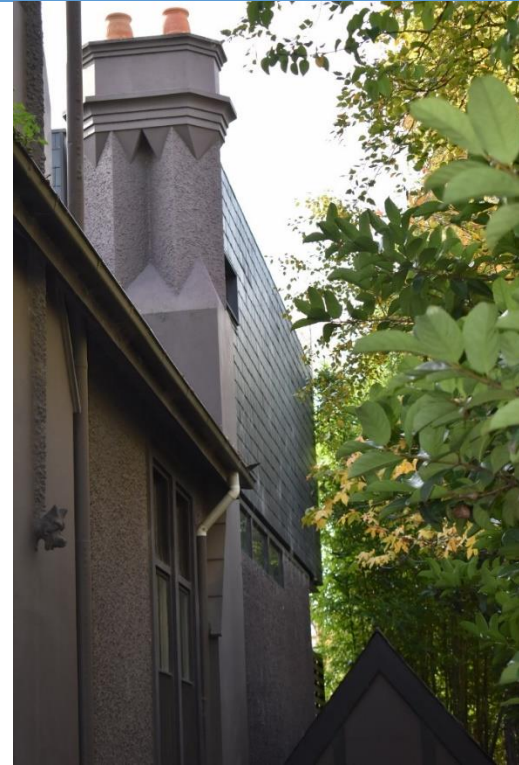
Chimney details on eastern elevation and the contemporary rear extension (source: Extent Heritage Pty Ltd, 2021).

A key feature of the structure is its four tall imposing chimneys. Three of the chimneys present a square roughcast form with a wide tapered base and an entablature form corbelled octagonal chimney cap with a terracotta pot. The fourth chimney has a similar form but with a doubled chimney stack forming a wider chimney. The contemporary back extension includes shingle style cladding, a flat corrugated galvanised iron roof and a row of skylights adjoining the original gable roof.

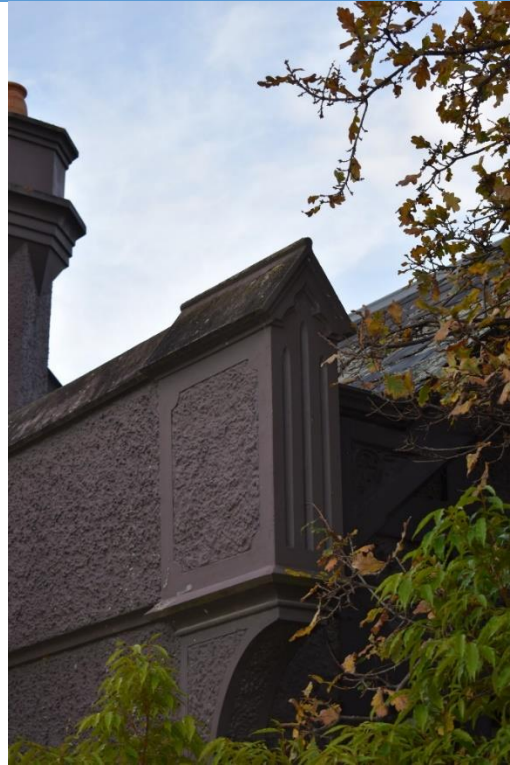
Flying party wall detailing on southwestern corner (source: Extent Heritage Pty Ltd, 2021).

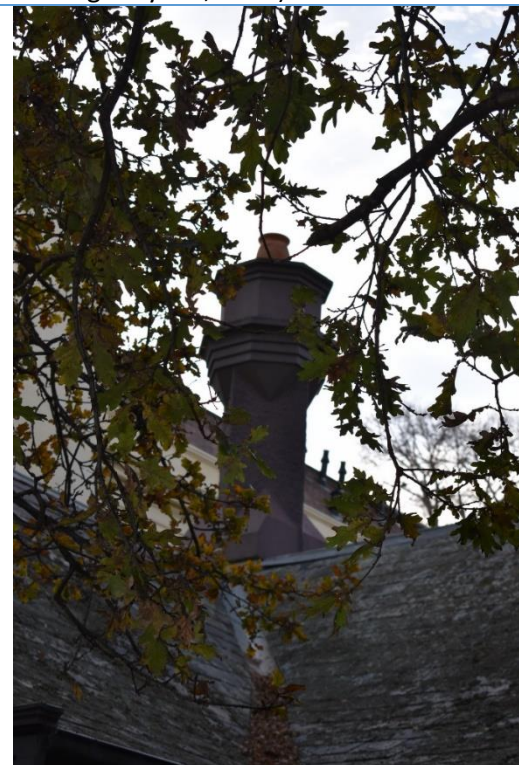
Chimney details (source: Extent Heritage Pty Ltd, 2021).

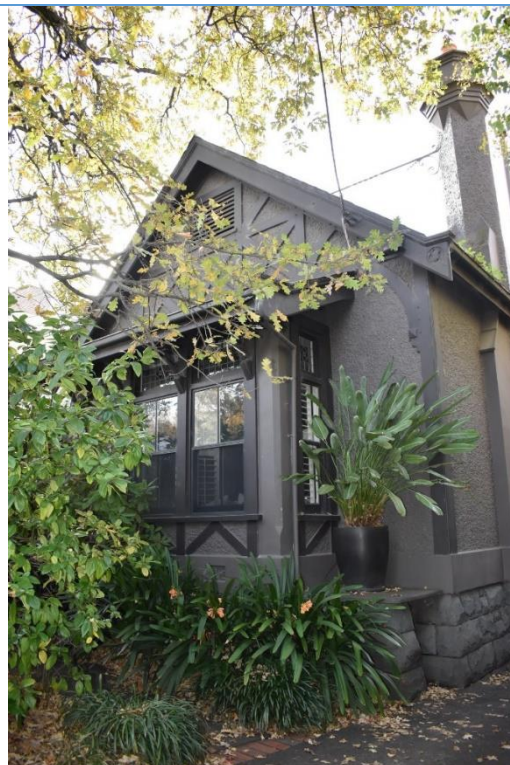
Detail view of the eastern projecting bay (source: Extent Heritage Pty Ltd, 2021).

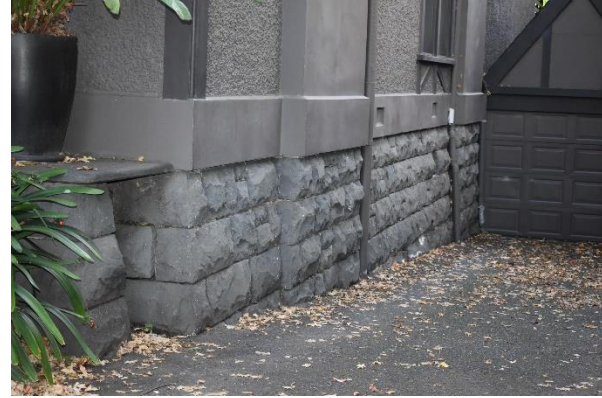
Bluestone foundation, eastern elevation (source: Extent Heritage Pty Ltd, 2021).

The right gable is met with a distinct bluestone block foundation that continues and runs along the entire east elevation. The three block course follows the slight slope of the site to become over six blocks tall where the garage meets the main structure. The single storey garage addition has a steep pitched gable roof with a three-section half-timber gable and counterweight garage door. The façade features a small dragon gargoyle located halfway up the ground level wall.

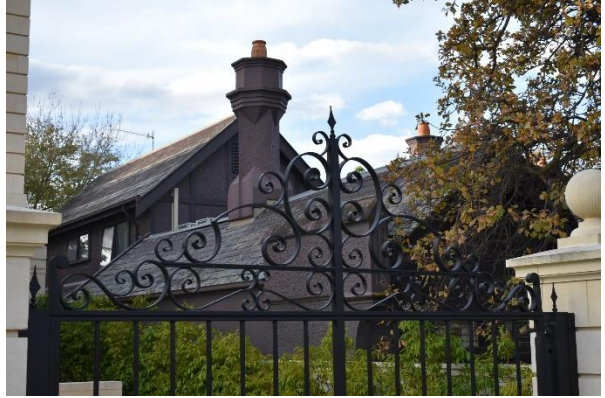
Oblique view of the rear extension, looking south east (source: Extent Heritage Pty Ltd, 2021).
