Heritage Citation – Individual Place

Heritage Place: Duart

Address: 29 Lansell Road, Toorak

HO Reference: HO727

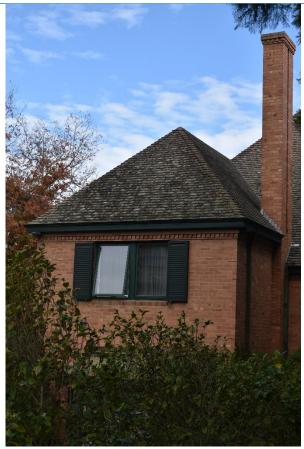
The façade Is stepped in its siting and includes a curved wall and low roof profile, both elements of which are notable from the street due to the slope of the site. The fenestration includes rectangular awning windows of varying sizes, including a semi-circular bay window with a metal roof on the façade at ground level and a large double awning window flanked with timber louvered shutters on the upper level.

Detail view of the upper level double awning windows with timber louvred shutters (source: Extent Heritage Pty Ltd, 2021).

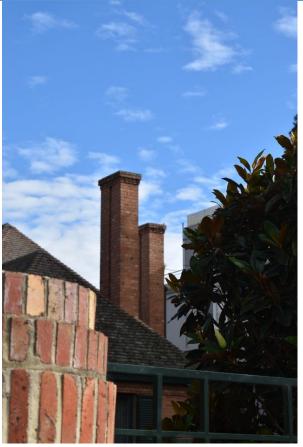
Detail view of the tall face brick chimneys (source: Extent Heritage Pty Ltd, 2021).
