## Heritage Citation – Precinct

**Heritage Place:** Clendon Road Precinct  
**Address:** 70-78 Clendon Road, Toorak

**HO Reference:** HO766  
**Citation status:** Final  
**Date Updated:** 22 March 2022

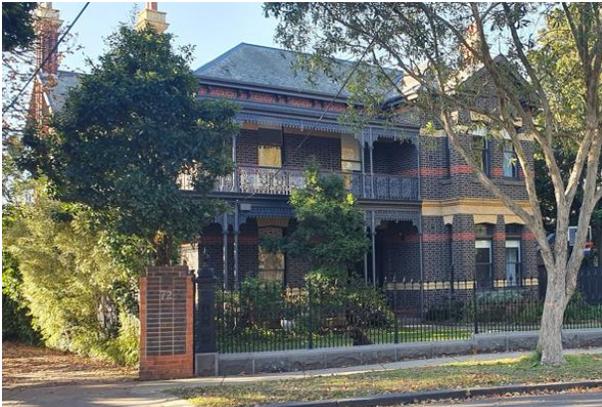
Photograph of 70 Clendon Road (source: City of Stonnington, 2021).

70 Clendon Road is a two-storey residence built in a Victorian era style. The masonry structure consists of polychromatic brickwork laid in a Flemish bond. The double fronted façade has a projecting gable roof and features a return verandah with ornate cast iron columns, valance detailing and a metal roof. The main double hipped roof is clad in slate with a metal roof ridge cap. There are four highly embellished polychrome chimneys with chimney pots projecting from the main roof. The structure features paired and single rectangular sash windows with a concrete sill. The front projecting gable window includes pointed window heads with a flat top. There is a single storey garage with a gable roof located beside the east elevation. The street front boundary is demarcated by a black iron palisade fence supported on a bluestone block base with cast iron gate posts containing a gabled cap and pointed ball finial.

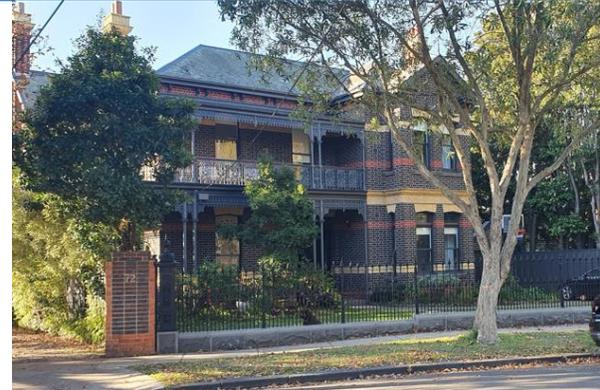
North-east facing view of 70 Clendon Road (source: City of Stonnington, 2020).

- Original red bricks repainted a liver colour (after May 2013).
- Curved detailed timber fence removed (after September 2017).
- New palisade fence with bluestone base and iron posts added.
- Front yard re-landscaped with several mature trees removed.

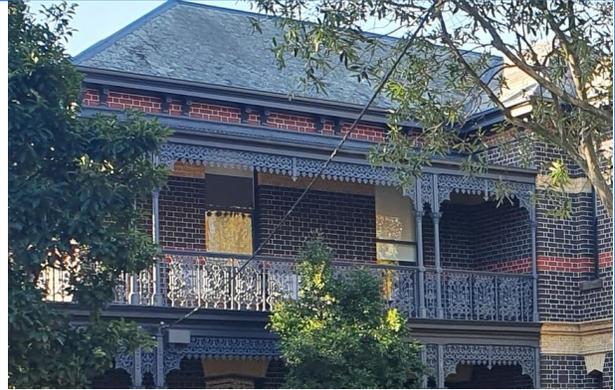
Detail view of upper floor verandah, fenestration and roof form at 70 Clendon Road (source: City of Stonnington, 2020).

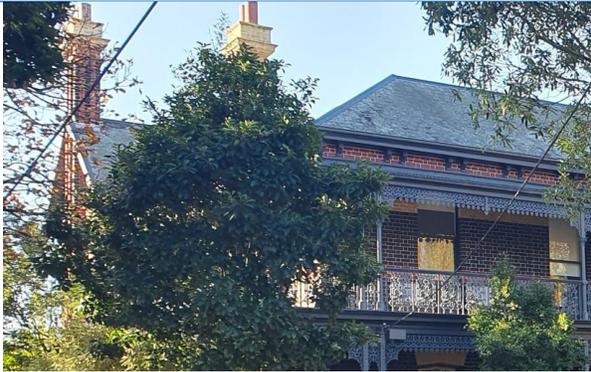
Detail view of chimneys, upper level and side elevation of 70 Clendon Road (source: City of Stonnington, 2020).

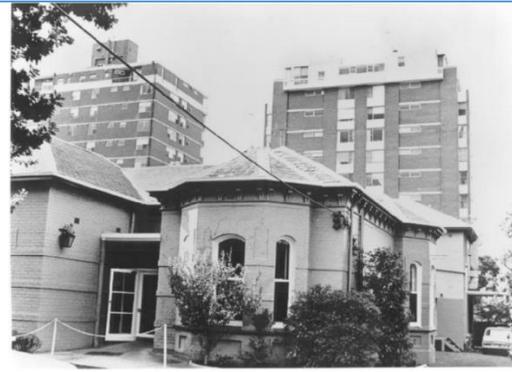
Black and white photograph of 72 Clendon Road in 1992 (source: Wilde, 1993).

72 Clendon Road is a single-storey residence built in a Victorian Italianate style. The masonry structure consists of painted bagged brick. The façade features expressed string courses and window moulds painted white, and a projecting octagonal bay with a hipped roof typical of the Italianate style. It has a complex hipped roof clad with slate and corrugated metal, metal roof ridge capping, two chimneys and a centred octagonal clerestory roof projection. The structure features rectangular sash windows with an angled concrete sill and a bracketed cornice. The street front boundary is demarcated by a tall open face red brick wall with a flat top laid in a common bond. The wall is flanked at the ends and the opening by a wide post with brown brick. The posts feature a metal plaque reading 'TOORAK SERVICES CLUB'.

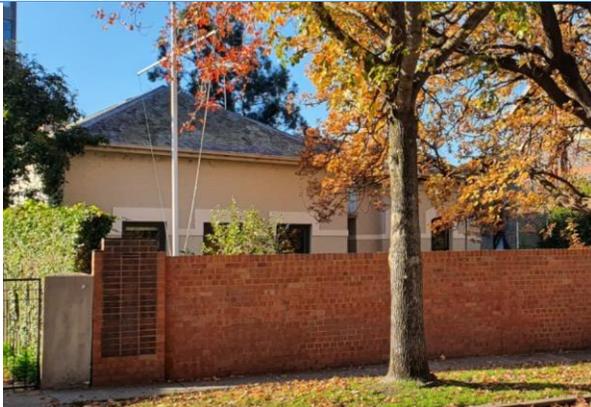
Façade of 72 Clendon Road (source: City of Stonnington, 2020).

- Sections of the roof reclad with corrugate metal.

- Sympathetic front extension added.
- Two-storey extension added to the north elevation.

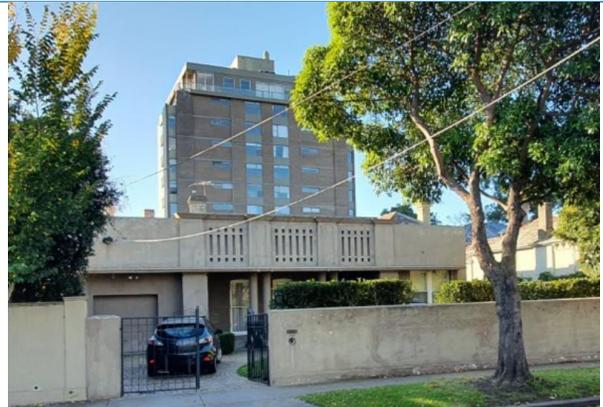
Façade of 74 Clendon Road (source: City of Stonnington, 2020).

74 Clendon Road is a single storey residence of masonry and render construction. The building would have been originally a Victorian era structure (as evidenced by the hipped roof form), although a secondary façade appears to have been added in the Interwar years.

The façade features a strong horizontal form with a recessed covered porch supported by two paired round columns. The rectilinear form is further emphasised above the front entrance with expressed engaged piers, recessed vertical rectangular motifs and a raised flat parapet. The structure consists of a complex hipped roof clad with slate and corrugated metal with metal roof ridge capping and six chimneys. The building has rectangular and arched sash windows. The street front boundary is demarcated by tall, rendered masonry wall with a flat top and black wrought iron gates. The return driveway is laid with blond brick and curves around a lawn area.

- Front façade infilled.
- Garage added to the front façade.
- Original front wall removed and rendered brick front wall added.

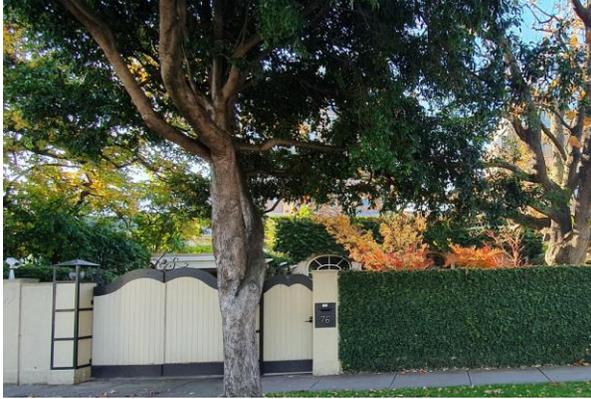
View of 76 Clendon Road from the street (source: City of Stonnington, 2020).

76 Clendon Road is a single-storey residence of a rendered masonry construction. The building would have been originally a Victorian era structure (as evidenced by the hipped roof form), although the façade has been altered. The façade features arched windows which mirror a recessed front entrance porch. The arched forms are flanked by rounded expressed column engaged piers. The structure consists of a complex hipped roof clad with corrugated metal with metal roof ridge capping and four chimneys. The street front boundary is demarcated by tall, rendered masonry wall with a flat top and square piers.

- Carport added to the driveway.
- Sections of the roof reclad with corrugate metal.

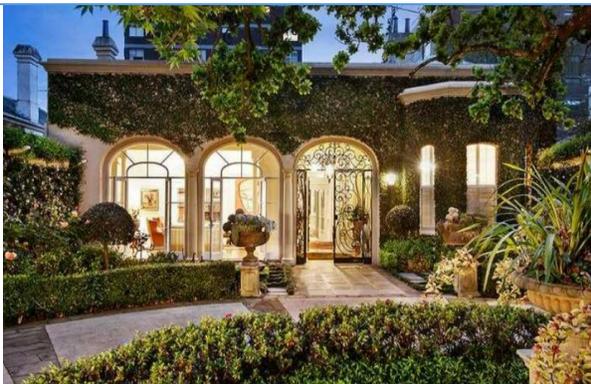
Facade of 76 Clendon Road from within property (source: [www.realestate.com.au](http://www.realestate.com.au), 2013).

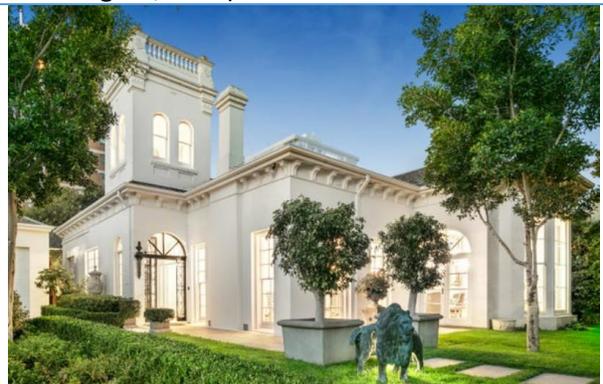
North-east facing view of 78 Clendon Road from within the property (source: [www.realestate.com.au](http://www.realestate.com.au), 2019).

78 Clendon Road is a single-storey residence consisting of masonry construction. The front façade features a projecting octagonal bay with a hipped roof typical of the Italianate style. The building has a complex hipped roof clad with slate and corrugated metal with metal roof ridge capping and six chimneys. There are rectangular and arched sash windows. The front entrance is set within a covered porch with an arched opening. A second storey tower extends above the covered front entrance. It features paired arched sash windows on each face with a dentilled sill. The tower is capped with a highly ornate dentilled and bracketed cornice mouldings and a balustraded parapet. The street front boundary is demarcated by tall, rendered masonry wall with a flat top and square piers.

- Rendered masonry front wall added.
- Sympathetic garage extension added to the front façade.

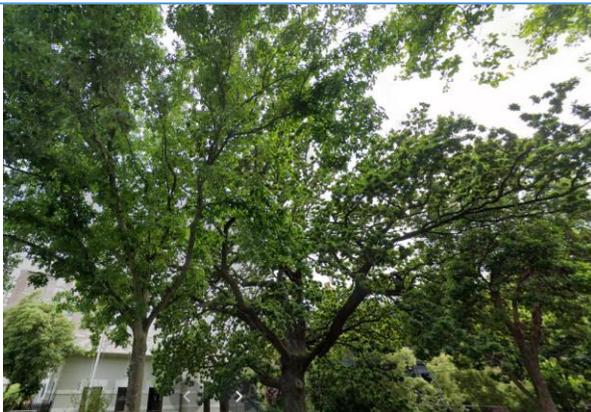
Mature oak (*Quercus*) tree in the front garden of 72 Clendon Road (source: Google Streetview, 2020).

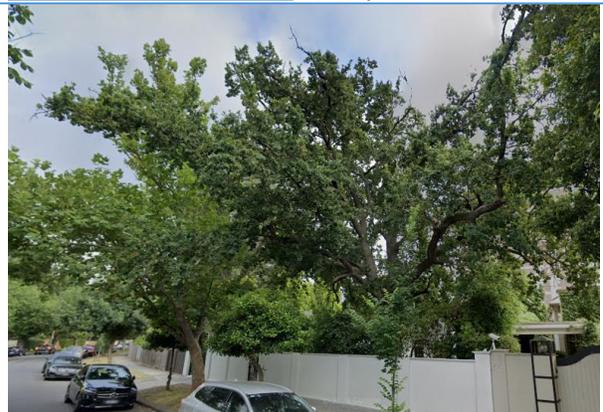
Mature oak (*Quercus*) tree in the front garden of 78 Clendon Road (source: Google Streetview, 2020).
