## Heritage Citation – Individual Place

**Heritage Place:** Residence  
**Address:** 762 Orrong Road, Toorak

**HO Reference:** HO90  
**Citation status:** Final  
**Date Updated:** 8 March 2022  
**Year of Construction:** 1924

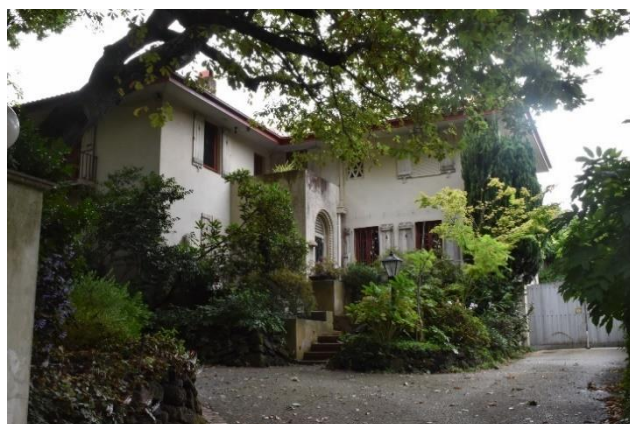
Photograph of 762 Orrong Road (source: Extent Heritage, 2021).

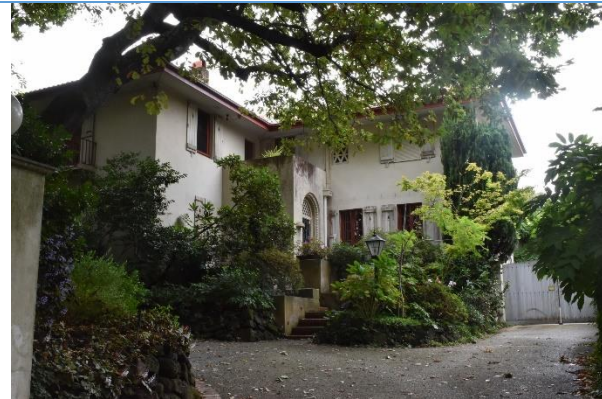
762 Orrong Road is a two-storey stucco rendered brick structure reflecting the Spanish Mission style. The structure has terracotta Cordova roof tiles with timber eaves and a red lintel. The stucco is a cream colour. The structure has three distinct wings, a main centre wing and two smaller projecting wings located asymmetrically on plan off the north and south façade. The entire structure is raised behind several short terraces with stone lined or cement retaining walls. The main entrance to the structure is located between the main and south façade wing. It is demarcated by a projecting porch with an accessible verandah on the upper level. The front door sits within a recessed arch, capped with honeycomb tracery, and framed by a barley twist moulding. The front door is accessible via brick laid steps.

The windows on the ground level are red timber eight pane casement windows. There are similar windows on the upper level as well as double hung sash windows. The windows have external timber shutters with an arrowhead motif. Some windows have external aluminum security shutters. The east façade closest to Orrong Road has a small balcony with red metal balustrade, red timber French doors and shutters. The north façade has three projections from the main structure. Two pitched roof extensions with a covered awning between the projections. The third projection is a covered porch and verandah. There are two roughcast chimneys with a terracotta cowl projecting from the main roof.

View of front façade, looking east (source: Extent Heritage Pty Ltd, 2021).

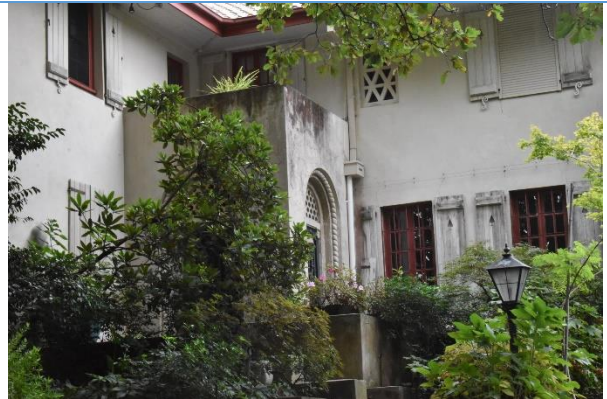
Detail view of entrance treatment, looking east (source: Extent Heritage Pty Ltd, 2021).

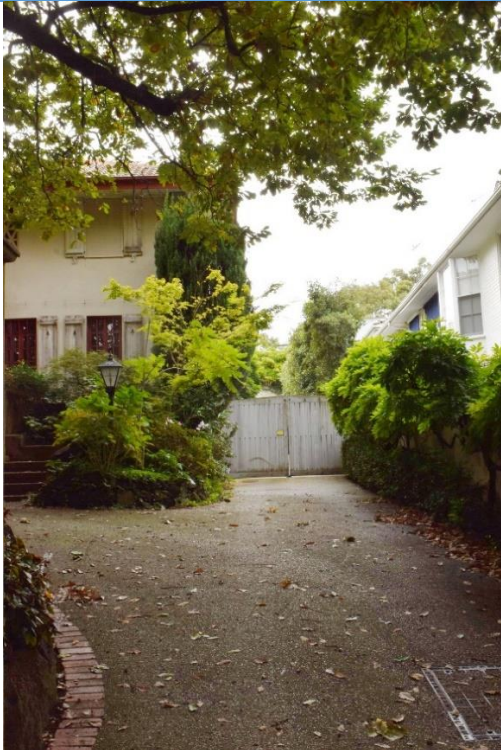
The grounds of 762 Orrong Road are highly landscaped with the terraced garden beds planted with shrubs and small trees. There is a pebble screed driveway lined with bricks along the border. There is a significant mature English oak tree (*Quercus robur*) located behind the boundary wall of the property which is reported to be older than the structure. The eastern portion of the property is paved with well-defined raised garden beds and a centrally located water fountain. There is a pool located off the north façade of the building. The street boundary is demarcated by a tall, rendered brick wall which does not appear to be original. The wall is capped with a shaped curved form following the rising gradient of the street. The entrances are characterised by a recessed wall with a shorter projecting garden bed within the wall structure. There is an additional timber lattice wall affixed behind a portion of the main wall.

View down driveway, looking east (source: Extent Heritage Pty Ltd, 2021).

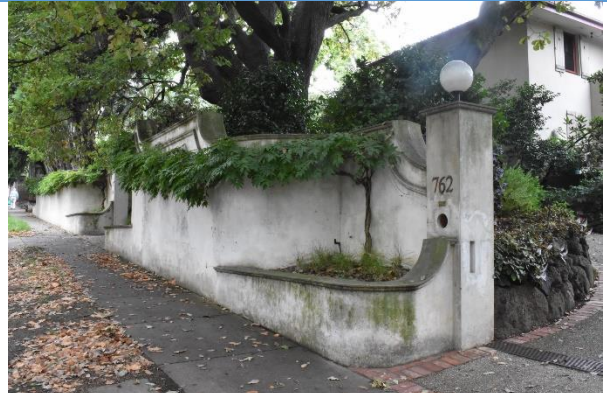
Western boundary fence (source: Extent Heritage Pty Ltd, 2021).

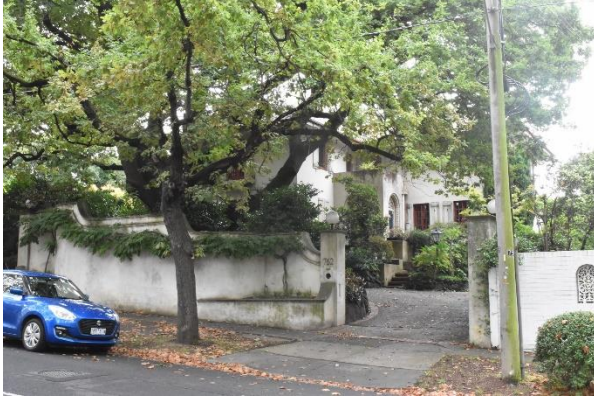
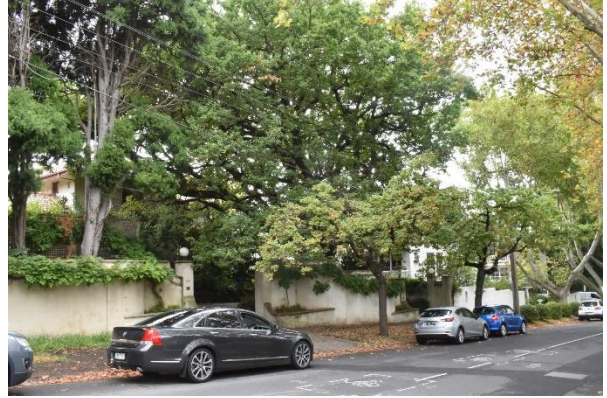
Given its remarkable size, the mature English oak (*Quercus robur*) tree situated in the front garden of the house is believed to be from an earlier 19th century garden of Villa Vera, a residence that predated the construction of 762 Orrong Road. Widely cultivated in the region from the mid 19th century, existing research suggests that this tree once comprised a carefully landscaped geometric garden (Hubbard 1992). Both the latter 1924 house elevation and front garden were thus likely designed with the tree in mind.

View of English oak (*Quercus robur*), looking north east (source: Extent Heritage Pty Ltd, 2021).

View of English oak (*Quercus robur*), looking south east (source: Extent Heritage Pty Ltd, 2021).

**Recommendation:** Retain as an individually significant place on the HO; tree controls are recommended in relation to the mature English oak tree (*Quercus robur*) on the western boundary.
