Heritage Citation – Individual Place

Heritage Place: Residence
Address: 23 Douglas Street, Toorak

HO Reference: HO307
Citation status: Final
Date Updated: 17 March 2022

Year of Construction: c.1890-1895

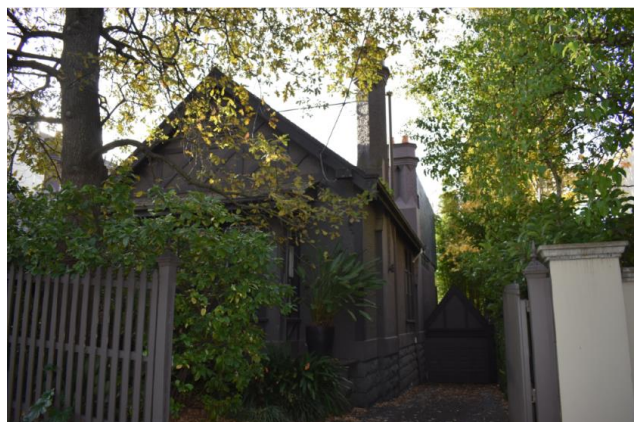
Photograph of 23 Douglas Street (source: Extent Heritage Pty Ltd, 2021).

23 Douglas Street is a double storey residence built in an Arts and Crafts style. The main structure is single storey at the front, moving to two storeys at the rear including a contemporary extension. The masonry structure is finished in a roughcast stucco. The black/grey colour of the roughcast is employed throughout the entire building and is not part of the original colour scheme. The structure employs a hipped roof with open gable projections clad in slate tiles. The front façade is almost symmetrical, with a slightly different eave treatment and fall between the two flanking open gable projections. The left gable falls lower than the right gable forming the porch awning.

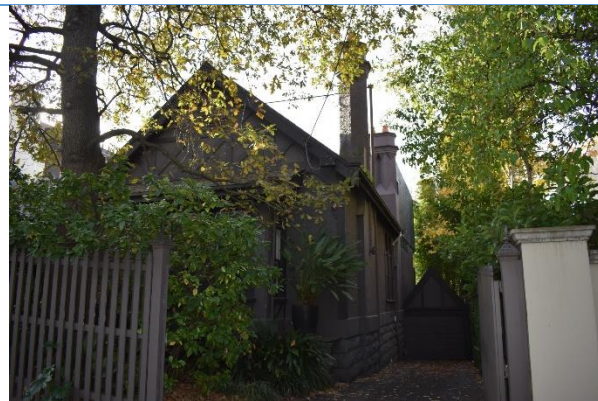
Oblique view of façade and eastern elevation (source: Extent Heritage Pty Ltd, 2021).

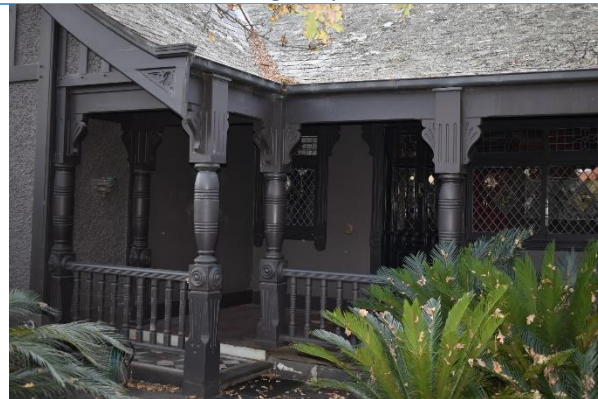
Verandah details on façade (source: Extent Heritage Pty Ltd, 2021).

The main entrance is located in between the two front gables and set under a deep porch. The porch is raised up two steps and laid with Old English tiles in a geometric pattern. The timber verandah elements are highly decorative. The turned timber posts are shaped into three distinct sections that are embellished with fluted patterns and patera motif. The porch is enclosed with a turned timber balustrade echoing similar horizontal fluting. The posts are capped with a heavy-set entablature with curved bracket-like valances. The windows along the porch wall are highly detailed diamond pattern fine leaded glass with stained glass flower motifs. The windows in the porch and along the exterior façades are set within highly detailed carved sash boxes that emulate the forms of the turned porch posts.

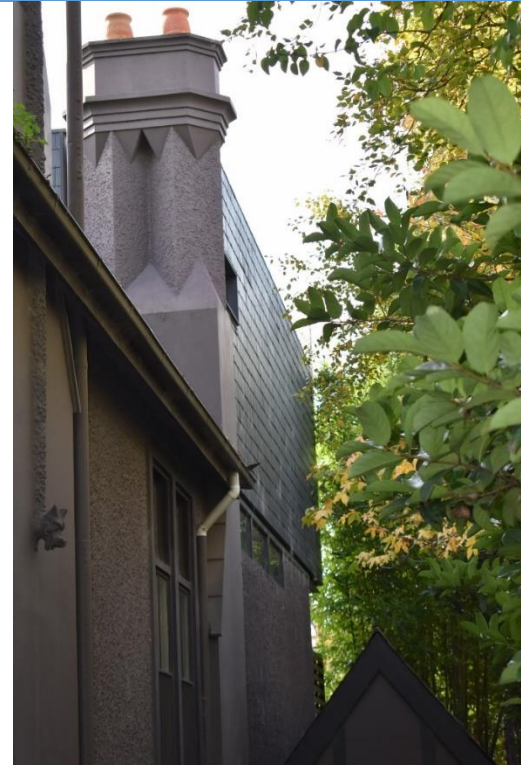
Chimney details on eastern elevation and the contemporary rear extension (source: Extent Heritage Pty Ltd, 2021).

A key feature of the structure is its four tall imposing chimneys. Three of the chimneys present a square roughcast form with a wide tapered base and an entablature form corbelled octagonal chimney cap with a terracotta pot. The fourth chimney has a similar form but with a doubled chimney stack forming a wider chimney. The contemporary back extension includes shingle style cladding, a flat corrugated galvanised iron roof and a row of skylights adjoining the original gable roof.

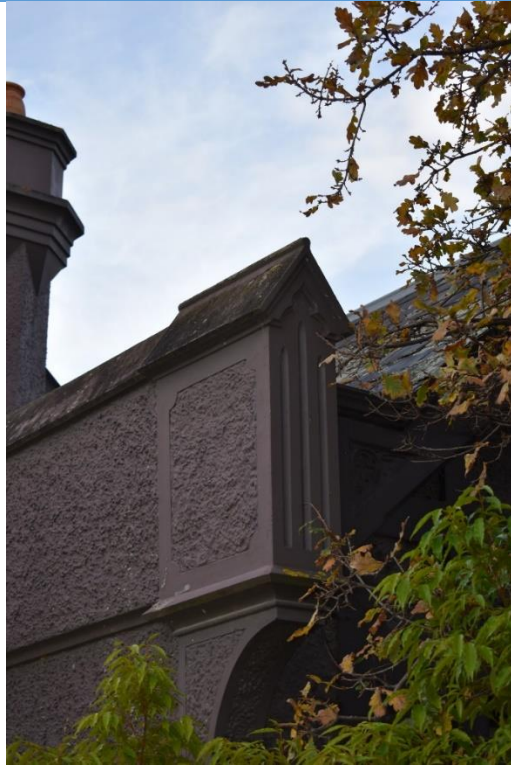
Flying party wall detailing on southwestern corner (source: Extent Heritage Pty Ltd, 2021).

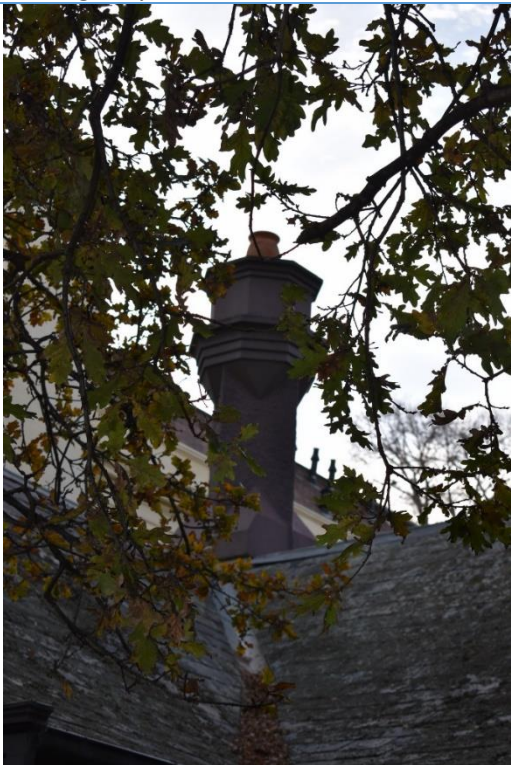
Chimney details (source: Extent Heritage Pty Ltd, 2021).

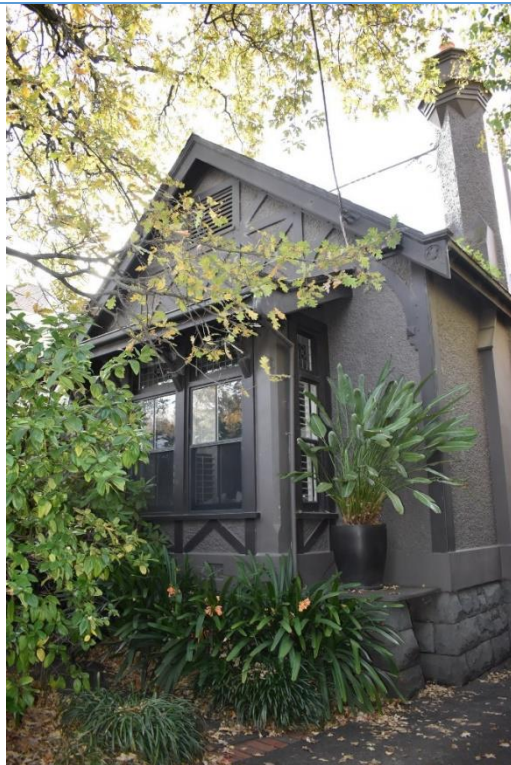
Detail view of the eastern projecting bay (source: Extent Heritage Pty Ltd, 2021).

The right gable end on the façade presents a feature bay window with a set of three windows on its front and two side windows. The windows present a same style as the left gable windows. The half timbering detail can be found under the windowsill incorporated into the sash box. The bay window is protected by a lean-to awning supported by four brackets. The half timbering battens continue above the awning incorporating the single timber louvred vent window.

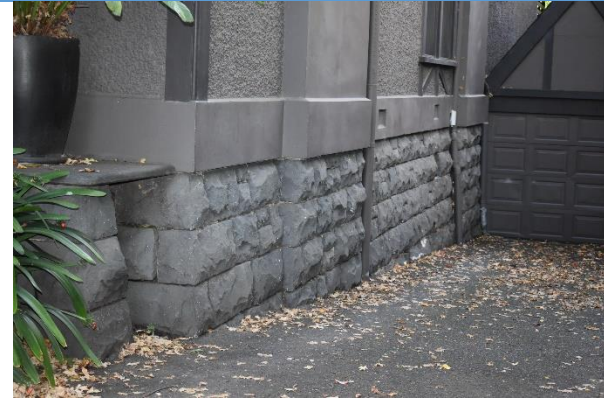
Bluestone foundation, eastern elevation (source: Extent Heritage Pty Ltd, 2021).

The right gable is met with a distinct bluestone block foundation that continues and runs along the entire east elevation. The three block course follows the slight slope of the site to become over six blocks tall where the garage meets the main structure. The single storey garage addition has a steep pitched gable roof with a three-section half-timber gable and counterweight garage door. The façade features a small dragon gargoyle located halfway up the ground level wall.

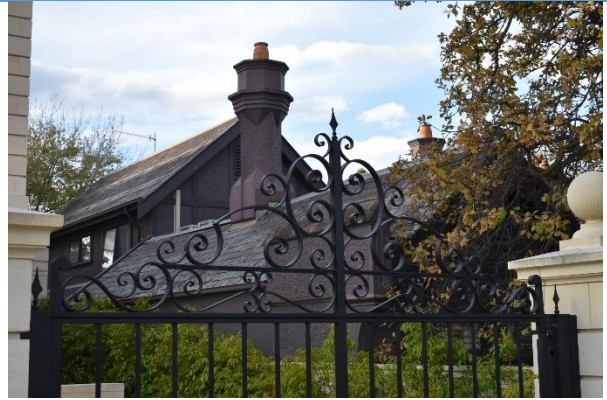
Oblique view of the rear extension, looking south east (source: Extent Heritage Pty Ltd, 2021).
